# Manhole Inspection Summary

Manhole # S02CC2014MH

Insp Date: **8/2/06 8:11 AM**

**Location** Address: **6704 Cross Country Blvd**

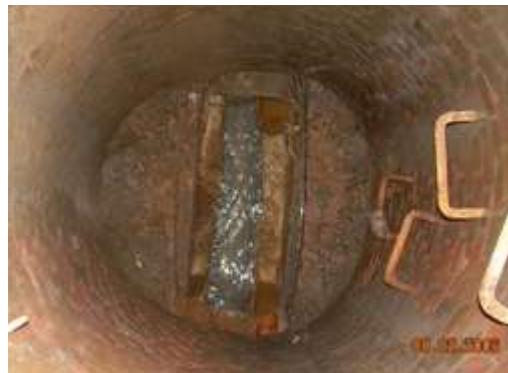
Top View

Infiltration: ☐ None ☒ **Joint** ☐ Cracks ☐ Mortar ☐ Roots ☐ Wall

☒ **Evidence Of Surcharge**

Depth: **3** (ft.) ☐ Active Surcharge Present

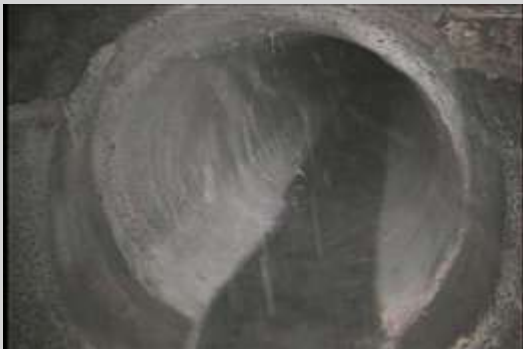
### 21 in. Circular Gravity Sewer Pipe In @ 6 O'Clock

Pipe Material: **Clay** ☒ Pipe Lined

Invert Depth: **9.44** (ft.) Flow Characteristics: **Fast**

Infiltration: **None** Pipe Seal Cond: **Sound**
